# Fracture of Zirconia Abutment with Metallic Insertion on Anterior Single Titanium Implant with Internal Hexagon: Retrieval Analysis of a Failure

*This case report presents a retrieval analysis of a screw-retained one-piece restoration with the veneering ceramic fired directly onto the zirconia abutment that fractured during insertion. A patient who experienced root fracture of a maxillary left central incisor received a titanium implant on the same day as extraction. After delayed implant loading, a two-piece zirconia abutment with metallic insertion was customized. Upon installation, a horizontal fracture of the crown just above the metallic portion was detected. The retrieval analysis of a fractured zirconia abutment showed crack formation and diffusion of glaze material that expanded the crack line during firing.*

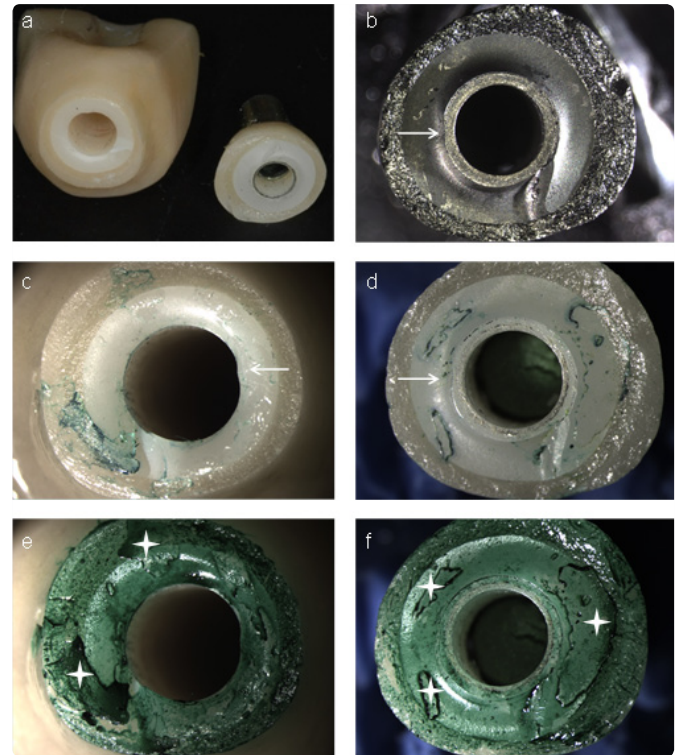
During the stereomicroscopic inspection, some areas of the abutment appeared shiny (Figure 2a-f).

The appearance of both fracture surfaces was that of a glassy material invading the abutment zone. The glossy aspect of such material suggested that it could be porcelain that had infiltrated the abutment zone in previously existing defects or defects created after adjustments and torque of the coping during proof.

**Figure 2a-f:** (a) Crown fracture that occurred immediately after installation. Optical images (15 x) of the fractured crown: coronal (b, d, f) and cervical (c, e) fragments, showing a constriction (arrows) in the inner edge of the abutment where we suspected the origin could be, and areas of the fractured zirconia zone covered with porcelain (stars). Gold-sputter and green stain were used to highlight the topography.

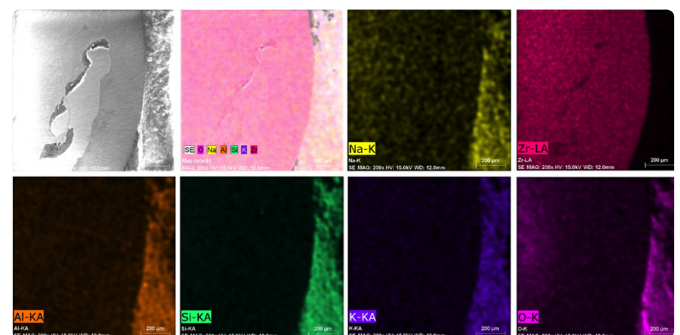
EDS analysis did not show unusual chemical elements in the dental ceramics used. Therefore, this excluded contamination as a possible reason for fracture. It also confirmed the presence of chemical elements of both the veneering ceramic and zirconia, such as oxygen, aluminum, potassium, sodium, zirconia, and silicon (Figure 3). The shiny portions on the zirconia abutment fractured surfaces showed the presence of the same elements, confirming the presence of porcelain between the broken surfaces of the abutment.

**Figure 3:** EDS mapping indicating the presence of chemical elements of both the veneering ceramic and zirconia, such as oxygen, aluminum, potassium, sodium, zirconia, and silica. No traces of contaminant agents were noted.

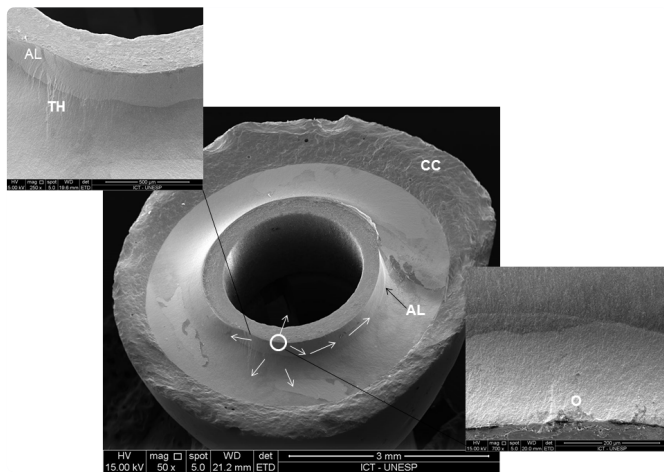
SEM analysis of the fragments also showed the existence of thin portions of porcelain between the two surfaces. Pores of various sizes were observed in the veneering ceramic as well as wake (a trail surrounding a bubble or discontinuity) and twist hackles (region where the tensile stress tilted from crack surface). Hackles are useful fracture marks that indicate the direction of crack propagation. The larger pores of veneering ceramic did not exceed 6  $\mu\text{m}$  in diameter. The presence of a concave region in the inner edge of the pillar was noted and arrest lines were soon detected (a sharp line on the fracture surface where crack stopped momentarily and continued under a more or less altered stress configuration) (Figure 4). Additionally, the existence of a compression curl (an important sign that the specimen either was loaded primarily in bending or had a strong bending component) indicated that the origin was in the inner edge, away from the concave region (Figure 4). The crack path direction was from palatal to proximal and buccal sides of the crown. Abutment fracture occurred well above the transition area between the metallic insertion and zirconia portion (Figure 2a).

**Figure 4:** SEM images of the cervical fragment showing the direction of crack propagation (white arrows), compression curl (CC), arrest lines (black arrow) encompassing the originating defect in the inner edge (circle), and twist hackles (TH). An approximate view (700 x) of the originating defect (O) is also shown.
