# In Vitro Failure of Crowns Produced by Two CAD/CAM Systems

Thomas J. Donnelly\* and F.J Trevor Burke†

*Abstract - Previous laboratory studies have demonstrated satisfactory fracture resistance of all-ceramic crowns placed using a resin-composite luting material and a dentine bonding system. This study investigated the fracture resistance of teeth restored using CAD/CAM technology, namely, Zirconia Based crowns and Cerec® produced feldspathic porcelain crowns, both luted with a self adhesive resin luting material (RelyX™ Unicem Clicker™ 3M ESPE). Standardized preparations were carried out on two groups of ten sound, unrestored, maxillary premolar teeth. Ceramic crowns were constructed to have a thickness of 2mm at their midline fissure. Compressive fracture resistance was determined for each group using a Universal Testing Machine. The failure modes were also examined visually and interpreted according to a chosen scale. Mean Compressive fracture resistance of 746 (147)N and 1630 (175)N were recorded for the Cerec® and Lava™ groups respectively; differences were statistically significant ( $p < 0.001$ ). The fracture resistance of teeth restored with Lava™ crowns is significantl

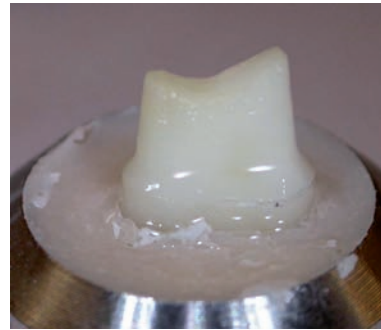
Figure 1. A typical preparation

- (1) A 2 mm groove was cut along the central fissure with a diamond bur marked to a depth of 2 mm.
- (2) A line was marked on the buccal and palatal cusps 2 mm from the cusp tips. This line was joined to the bottom of the groove prepared in (1) using a tapered diamond fissure bur (HiDi 501, Dentsply Ash Instruments).

- (3) Any convexity from the buccal, palatal, mesial and distal surfaces was removed using a tapered diamond fissure bur, with a finish line on enamel, 1 mm from the CEJ.

- (4) An axial taper of 6° was created using specially constructed tapered diamond burs of 6° divergence held in a laboratory handpiece operating at 8000 rpm without water coolant, placed in a Bachmann design parallelometer.

- (5) Any sharp preparation angles were rounded using a tapered diamond fissure bur in a high speed handpiece operating with water coolant.
- (6) The preparation margins were completed to a 0.5 mm shoulder preparation.

Stages 1-3 and 5-6 were carried out using a high speed handpiece operating with water coolant. Figure 1 presents an example of a preparation utilised in the study.

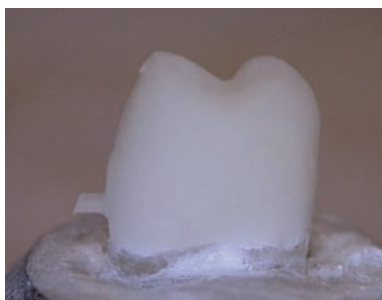
Figure 4. Crown milled with sprue attached and tried in

A one-stage impression of each prepared tooth was taken using a polyether impression material (Impregum™, 3M ESPE Seefeld, Germany) in a stock plastic tray painted with tray adhesive. Original impressions were poured using artificial diestone. Each die was then scanned, the resultant optical impression was manipulated to supply a close fitting coping of 0.6mm minimum thickness but designed

using the Digital Wax Knife (3M ESPE) to produce a contour which would allow a minimum thickness (*circa* 1mm) of the veneering porcelain, Lava Ceram (3M ESPE, Seefeld, Germany). When completed, the fitting surface was treated by air abrasion with CoJet™ (3M ESPE), a silica deposition device which has been found to create an adhesive bond when used with a silane bond enhancer (Sil™ 3M ESPE)<sup>9</sup>.

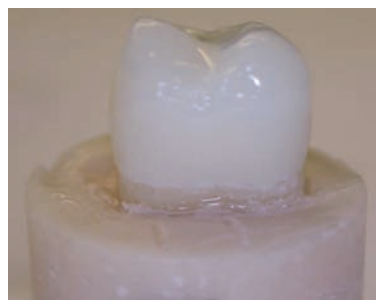
Figure 5. Crown glazed and fitted

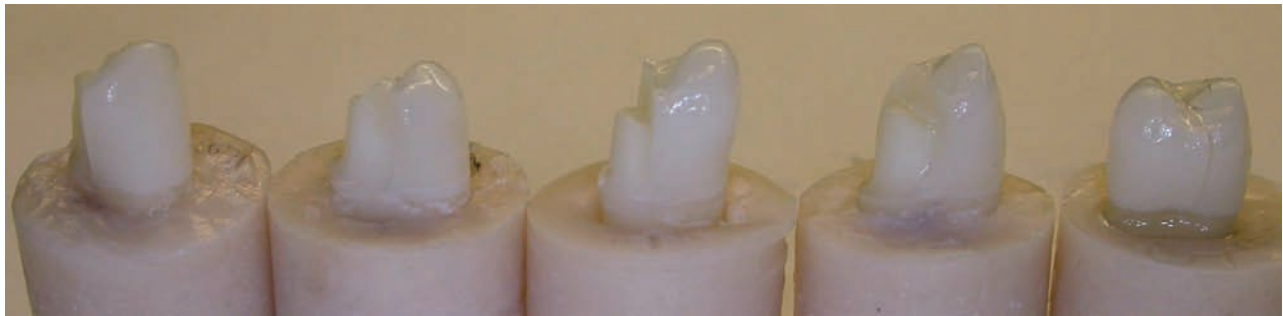
**Figure 6.** Mode II and mode III Cerec® crown fractures

- I minimal fracture/crack in crown/veneering.
- II < ½ of crown/veneering lost.
- III Crown/veneer fracture through midline; ½ of crown/veneer displaced/lost.
- IV > ½ of crown/veneer lost.
- V Coping fracture
- VI Tooth, Crown / Coping Fracture

There were differences in fracture mode between the groups (Table 1), with one (severe) mode VI fracture occurring in the Cerec® group, with 40% of crowns exhibiting a mode I fracture, 30% a mode II fracture (Figure 6) and 20% mode III fractures. Forty per cent of crowns in the Lava™ group exhibited a mode II fracture (Figure 7), 10% a mode III fracture, 30% a mode IV fracture, 10% a mode V fracture, and 10% a mode VI fracture. In all cases of failure the results would have necessitated clinical replacement of the crown, with the exception of the (severe) mode VI fractures, in which the failed tooth structure which would have resulted in extraction of the remaining tooth tissues.

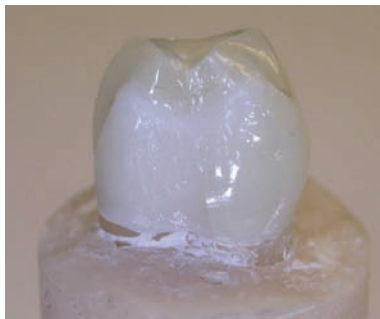
**Figure 7.** Mode II Lava™ crown fracture

A feldspathic porcelain (Lava Ceram) is used to veneer the Lava™ coping. One report has considered that the bond to the Lava™ coping may be a weakness of the system<sup>19</sup>. However, of the Lava™ crowns tested in the present study, 80% of the failures were within the porcelain veneer, rather than at the zirconia/veneering ceramic interface. It may be considered interesting to note that, although the veneering porcelains are relatively 'old' technology, the zirconia coping appeared to enhance their performance, since the mean fracture resistance of the Lava crowns was significantly higher than that of the group in which feldspathic porcelain was employed (the Cerec® group). That this was happening at twice the average load applied to the Cerec® crowns may be considered to demonstrate a potential for good clinical performance, although the forces that generated failure here may not be those that normally result in clinical failure.

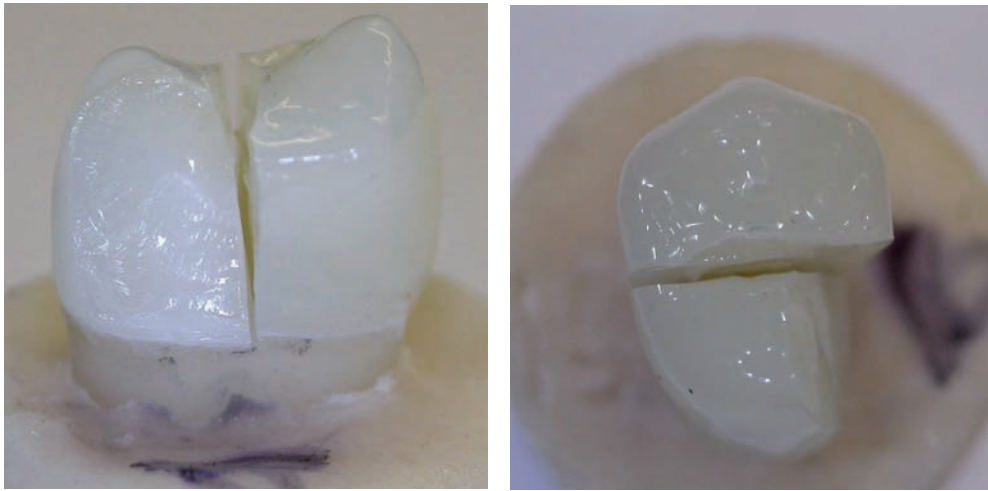
**Figure 8.** Mode VI catastrophic failure of the Lava™ crown

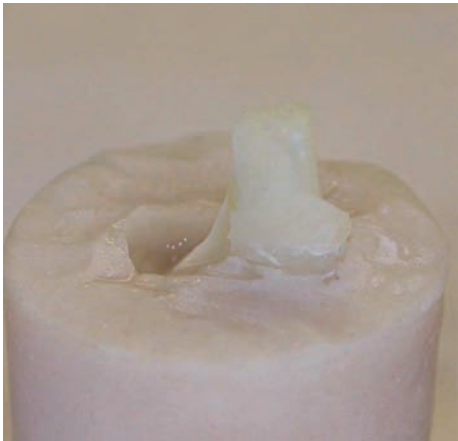
**Figure 9.** Mode VI catastrophic fracture of Cerec® crown
