# Replacing Amalgam Restorations : A Standardized Protocol Based on Analyzing Tissue Physicochemical Modifications

The aim of this article is to develop toughness about procedures for replacing amalgam restorations by composite. Our propositions will be based on analyzing and understanding tissue alterations caused by the physical and electrochemical properties of the material.

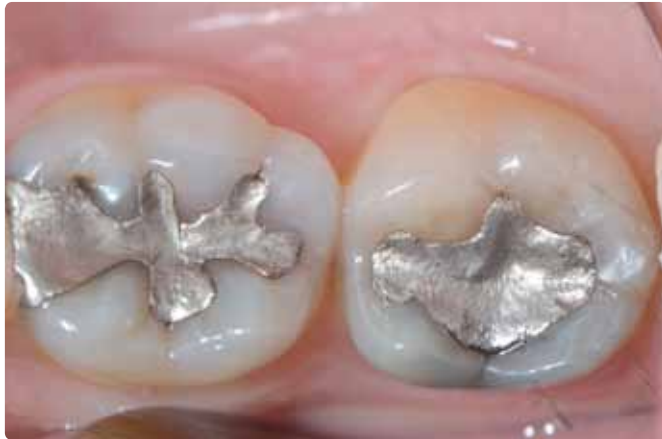
**Figure 1:** Amalgam restoration that needs replacing

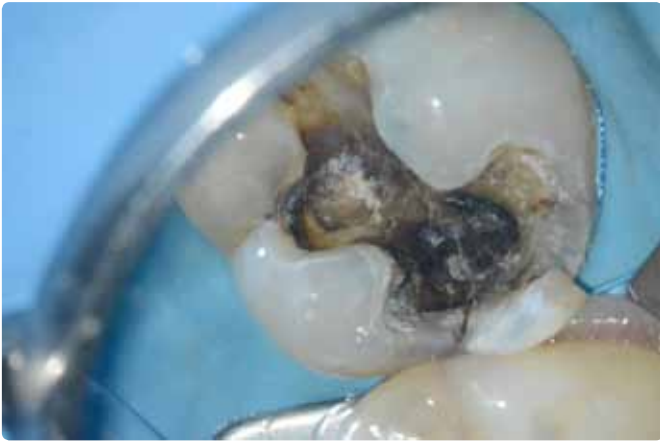
**Figure 2:** Corrosion products

A wide variety of corrosion products has been identified:<sup>6</sup>

- copper and tin oxides
- tin and zinc simple hydroxides and hydroxide complexes
- copper and tin oxy- and hydroxychlorides
- copper chlorides
- silver, copper and mercury sulfides

These ions and molecules are released at the tooth-material interfaces and progress to the restoration margins. Their minuscule size enables them to infiltrate dentin tissues and modify their composition. Due to low solubility, they tend to form precipitates that are able to penetrate the ultrastructure of the dentin.<sup>7</sup> Their transforming and penetrating capacities are determined by the order of magnitude of corrosion products -nanometer level- and their agglomerates -0.1 micrometer.

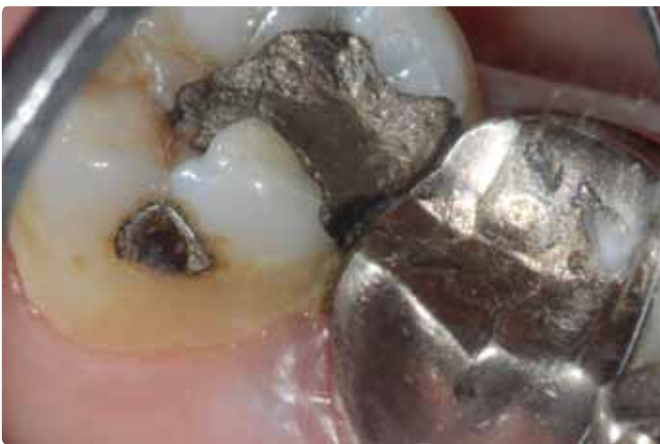
**Figure 3:** Concentration cell

In amalgam restorations, corrosion occurs in the occluded oxygen-deficient areas, predicted by the Evans effect (oxygen concentration cells). Because of a mechanism of differential oxygenation,<sup>3</sup> corrosion products will build up along the marginal area, i.e., below the proximal contact point and below the filling. As soon as the amalgam is placed, differential pitting corrosion occurs, as shown by the Evans effect. The resulting metallic oxides -electronegative compounds- are released in the dentine. This galvanic cell is then maintained by the saliva electrolyte at the amalgam-dentine junction.<sup>3</sup>

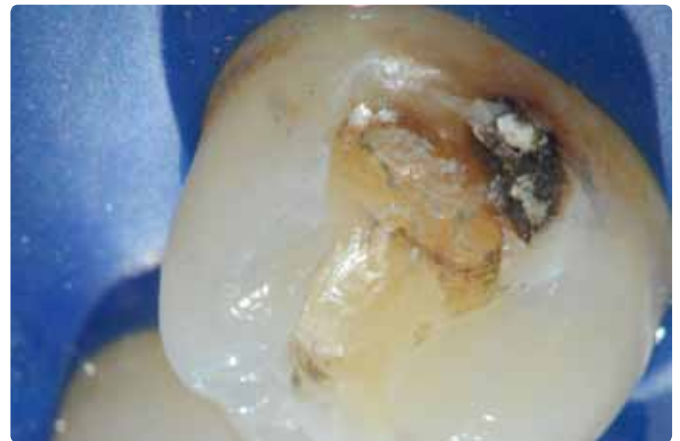
**Figure 4:** Amalgam residues on the enamel margin of a premolar

The biological effects of corrosion on enamel have not been studied extensively. This may be because the non-mineralized spaces between the prisms are only a few nanometers wide and they are filled with proteins and water. This makes it possible for corrosion products to pass through and diffuse into the tissue. These effects are not very significant but they may occur micro-cracks. That is why, in the case of posterior restorations, the quality of the enamel margin has to be assessed. Corrosion products can also remain on the enamel surface after the amalgam has been removed.

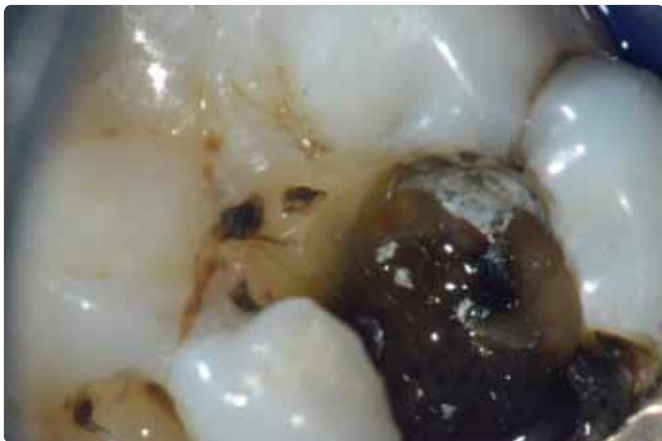
**Figure 5:** Corroded layer of dentine after amalgam removal

Clinically, removing an amalgam restoration often reveals a layer of darkish dentine of variable thickness typical of the corrosion process. The deeper the layer or the more deprived of air it is, the darker. Indeed, this deep dentine is both more fluid filled and permeable, and more anaerobic. The spectrophotometric analysis of the layer shows that tin is always present and zinc or copper may be found at the amalgam-dentine interface. Even when the dentin beneath the amalgam is not discoloured, there is metal ion release from the contact

surface area. This can be as deep as a few tenths of a millimetre.<sup>7,9,10</sup> Over the time ions progress with a penetration in order of 1 or 2 mm and results in visible corrosion products.<sup>11</sup>

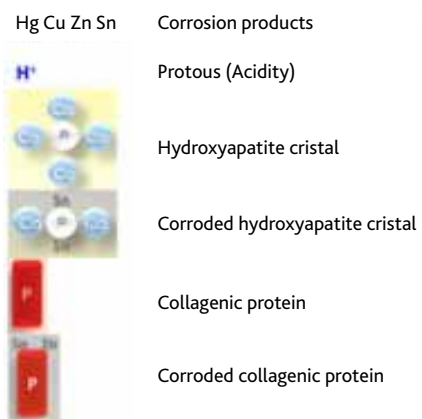
**Figure 6:** Overview of the release of corrosion products within the dentin of a vital tooth.

In short, the acidity from the amalgam-tooth interface demineralizes the dentine surface and releases collagenic proteins. The corrosion products bind to them and accumulate to form the surface corrosion layer, i.e., the darkish coloration which is clinically visible when removing the amalgam. The metallic oxides then extend into the dentine. The calcium ions are replaced by tin and zinc ions to form the replacement corrosion layer. The layer exists even in the case of non discoloured dentin.<sup>7</sup> Deeper in the tissues, corrosion products are released mostly within the dentinal tubules along an age-related concentration gradient, with concentrations getting lower as the further away the zone is from the restorative material.<sup>11,12,13,14</sup>

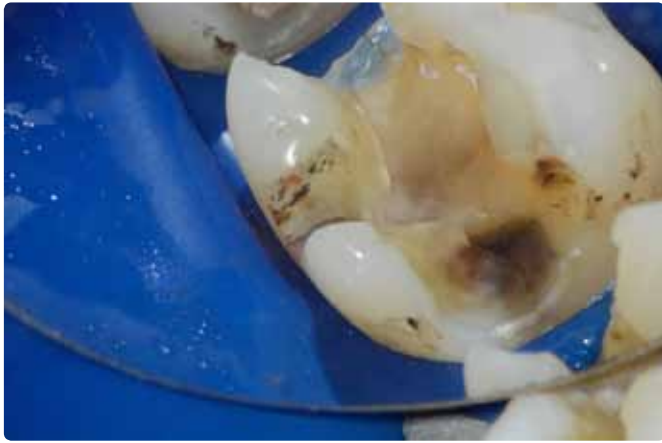
**Figure 7:** Distal crack underneath amalgam restoration

Clinically, similar cracks are often present in large amalgam-filled teeth. Based on scientific papers, a significant difference in crack prevalence has been shown between amalgam restorations and composite restorations<sup>17</sup> and between amalgam restorations and healthy teeth.<sup>18</sup>

Thus, microcracks occur as a consequence of masticating forces on weakened cusps, together with the different physical and chemical properties of amalgams and dental tissues. Due to repeated occlusal forces, fatigue cracks may appear and extend over time associated with pulpal or mechanical consequences.

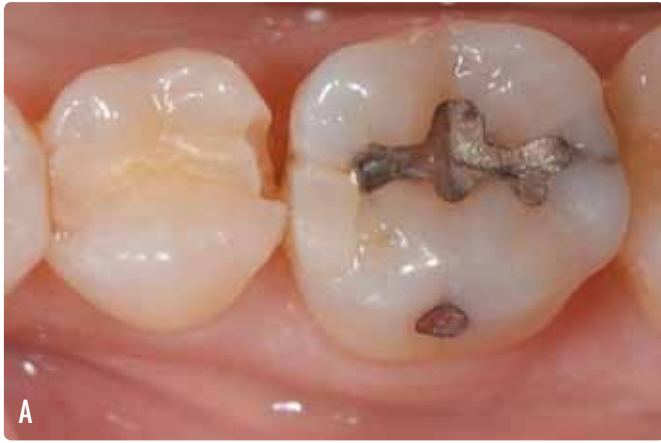
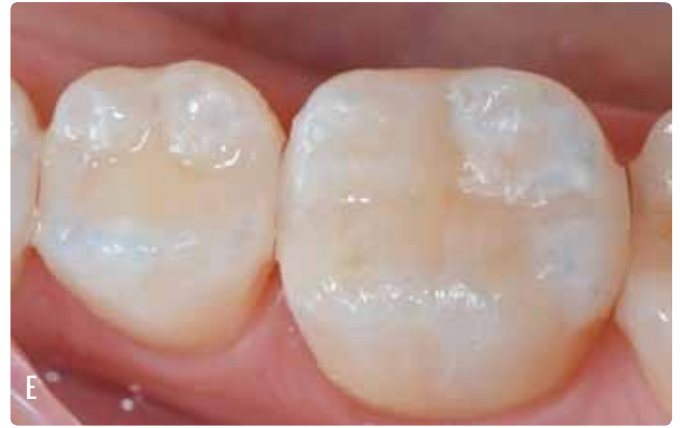
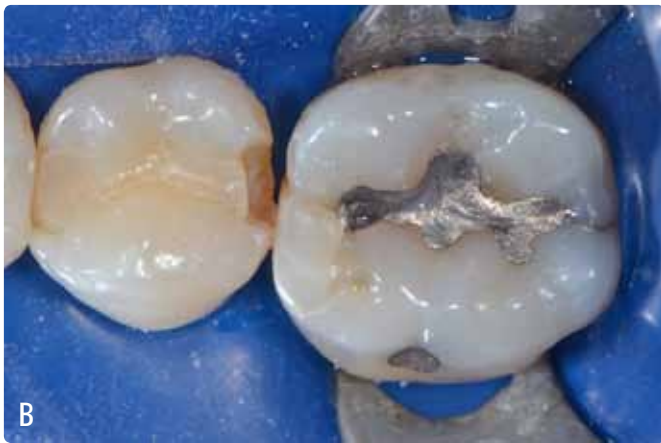
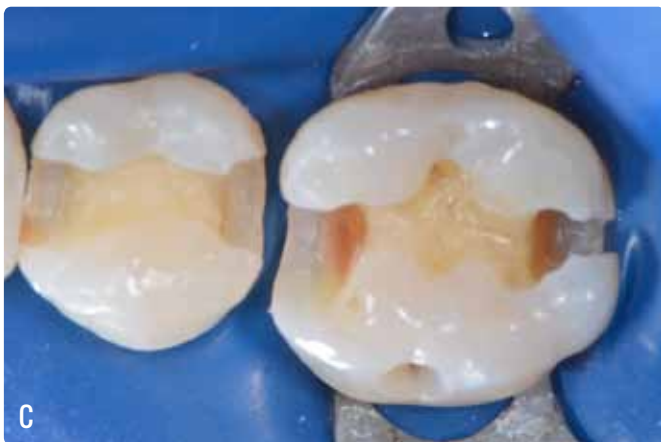
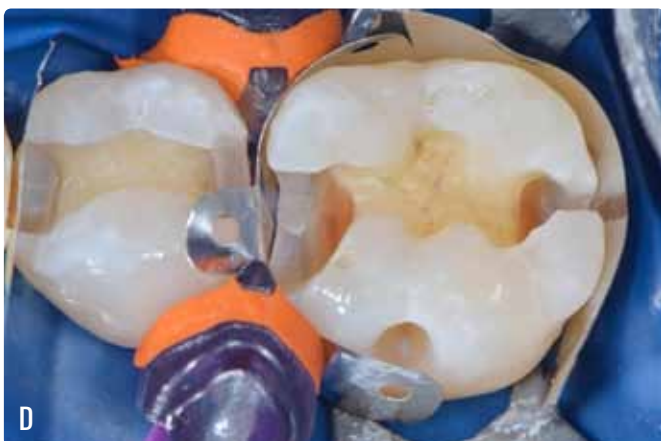
**Figure 8:** Clinical case with little substance damage

This is the most favorable situation as loss of enamel and dentine is minimal and the dentine along the axial and pulpal walls is sufficiently thick. To optimize bonding efficacy, it would be appropriate to remove all the corroded dentine. Then, we could proceed in the elimination of the stained tissue or, if it is not discoloured, a thin surface layer of approximately 0.5 mm, to obtain a dentine surface adapted to hybridization. In these instances, this microsurgery will have no impact either on the mechanical resistance of the tooth, or on its pulpal health (clinical case).

However, the reactionary dentine layer, that is often observed in case of old restorations, should be left untouched to maintain the natural protection of the pulp due to the reduced dentine permeability of this tissue. The bonding protocol will thus be carried out optimally.<sup>15</sup>

Removing the corroded dentine layer from a small restoration is absolutely necessary to restore optimal bonding strength. This procedure is to be performed with an excavator, a round tungsten or diamond bur or by means of air abrasion or ultrasonic abrasion. This protocol that is well-adapted to the replacement of small-sized restorations is conducive to optimal esthetic integration and ensures the best adhesive seal.<sup>21</sup>

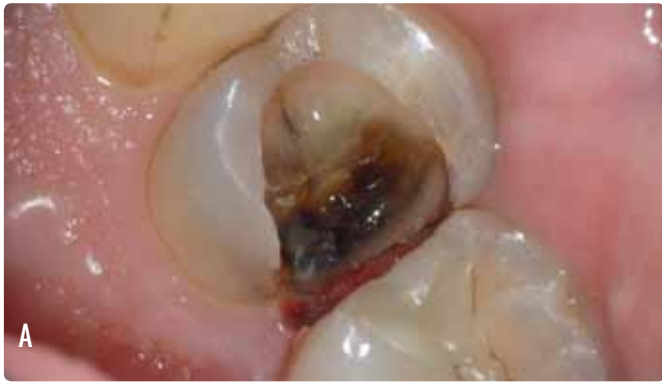
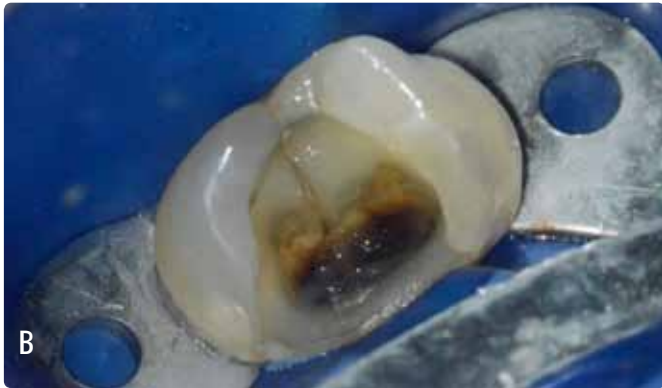
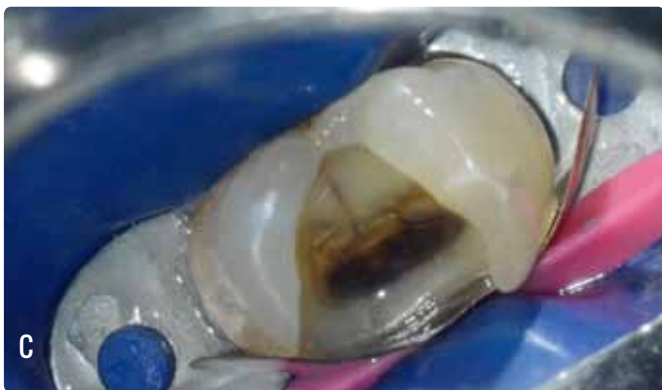
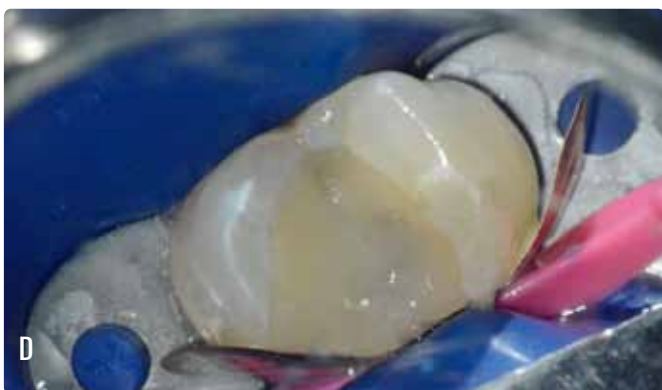
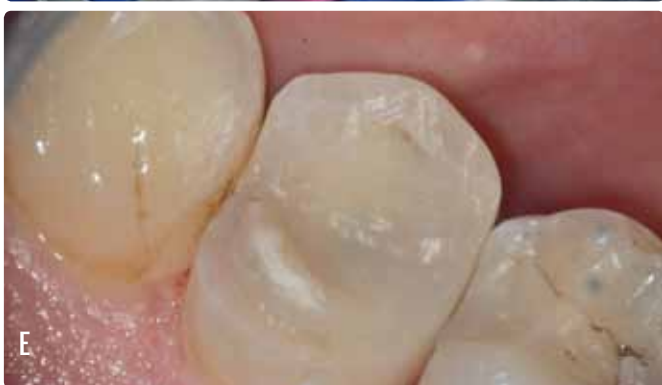
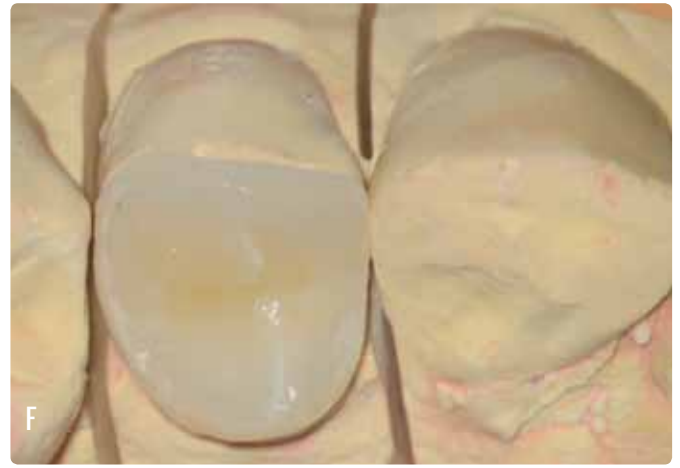
**Figure 9:** Clinical case showing extensive damage of coronal tooth tissue

Preparing the cavity after removing the amalgam is similar to managing deep extensive caries - a centripetal, differentiated protocol for tissue elimination has to be followed. The objective is to ensure the peripheral seal of the restoration as well as to limit pulpal involvement. The first step is to adjust enamel contours to achieve a healthy peripheral dentinal surface, particularly at the enamel-dentin junction, to obtain the best marginal fit and optimal bonding strength values (in the range of 30 to 55 MPa).<sup>20</sup>

The second step consists in carefully removing the corroded dentine from the whole cavity floor, except at juxtapulpal walls. Given corroded dentine bonding strength values are lower by about 20 MPa,<sup>20</sup> it is important to retain only a small surface. This approach may be likened to that used to treat deep carious lesions.<sup>23</sup>

This approach strikes a good balance as it makes it possible to use the peripheral dentine surface for bonding and leaves bioactive self-sealing corrosion products next to the pulp. It provides pulp and dentine protection. Hence, bonding protocols can be implemented on these surfaces directly, with no dentine substitutes.

If a dentine substitute is necessary (sandwich technique), using a glass ionomer cement seems to be the best solution to obtain adequate bonding strength. Theoretically, its capacity to form a chemical bond with metal oxides makes it appropriate.<sup>24,25</sup>
