Zirconia-Reinforced Lithium Silicate Ceramic - A 2-Year Follow-up of a Clinical Experience with Anterior Crowns

Rehabilitation
Aesthetic Dentistry
Dental Ceramics:
Zirconia
Anterior Crowns

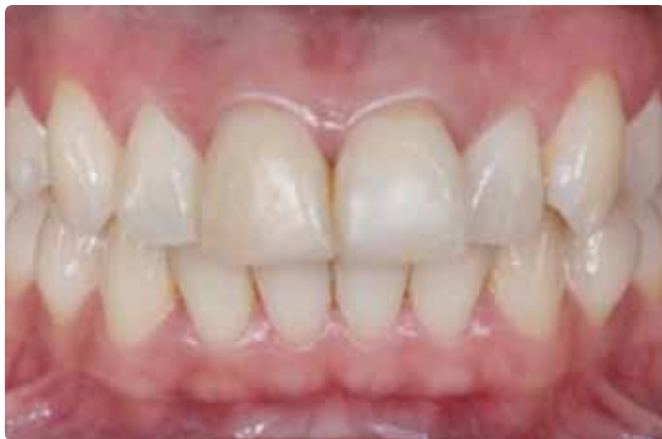
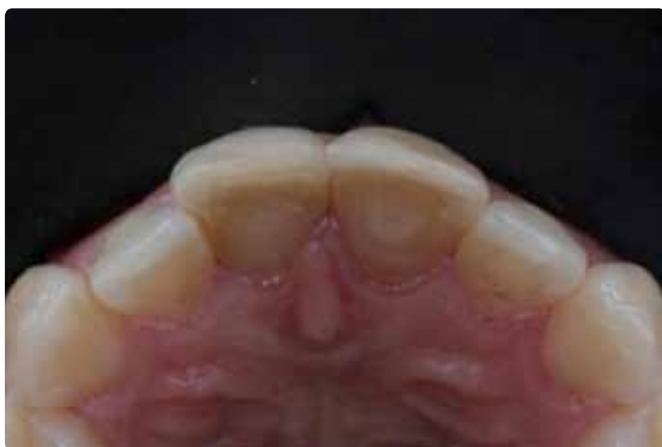
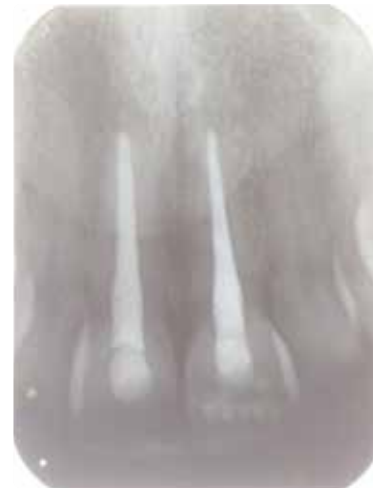
Figure 1a-c: Intraoral pretreatment photograph showing incisor discoloration and degradation of composite resin restorations: (A) facial view and (B) incisal view; (C) initial periapical radiograph showing presence of endodontic treatment of central incisors. Note that it is also possible to notice buccal projection of left maxillary lateral incisor.

In the first clinical session, occlusion and mandibular anterior teeth esthetic and functional conditions, anterior guidance, esthetic profile, and smile harmony were analyzed. Initial appearance is illustrated in Figures 1A and B and the periapical radiograph in C. Impressions with irreversible hydrocolloid were made for diagnostic casts and maxillary references check of median line. Diagnostic casts were then used for anatomic diagnostic wax up for the first mock-up. An initial silicone guide was used to preview the need for palatal incisors repositioning (dental tissue to be removed). An inclination guide was applied for esthetics and functions re-establishment.

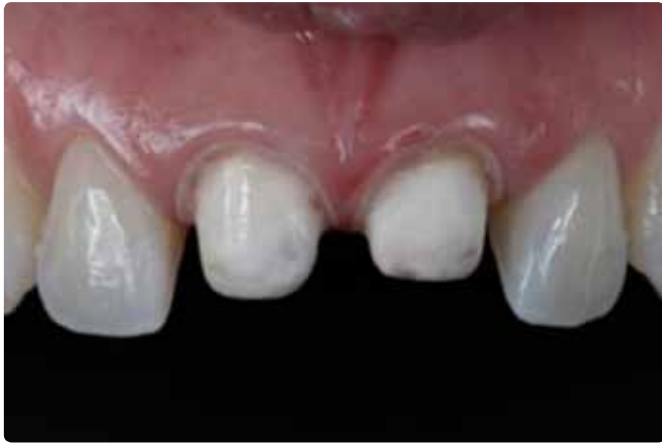
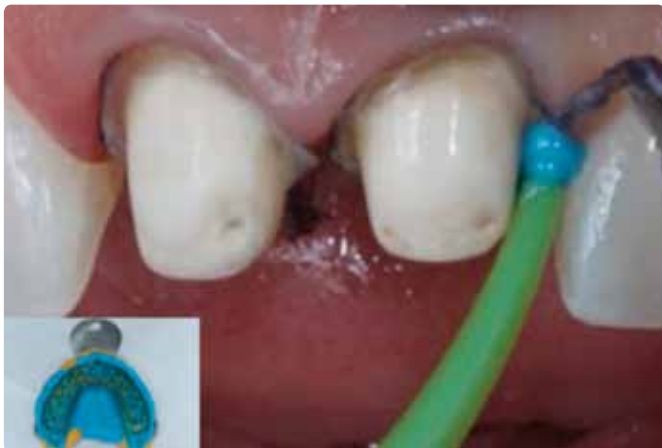
Figure 2a-b: (A) Tooth preparation for ceramic crowns made using Suprinity Vita Ceramic; (B) Functional impression with poly (vinyl siloxane) impression material (addition-polymerized silicon) in 2 phases: (i) high viscosity and (ii) low viscosity. Note gingival retraction for moist control and to aid evidencing of cervical subgingival margins of preparation.

All older composite resin restorations were removed by using a spherical and cylindrical diamond bur. Maxillary-central incisor teeth were prepared in the second session with a 0.5 mm supragingival chamfer. Preparations were finished with burs and polished with diamond rubber tips. Provisional crowns were prepared using a cross-sectioned silicone mold previously made using the diagnostic wax up. After teeth preparation, acrylic resin was poured in the mold and applied onto the prepared teeth. In the third session, the provisional anterior teeth were removed and double-cord technique was applied, with the cord impregnated with a hemostatic solution (Figure 2B). Definitive complete-arch, 2-phase impression was made with a combination of heavy- and light-viscosity poly (vinyl siloxane) material (Figure 2B). Master impressions were obtained (Figure 3A) and the functional waxing (Figure 3B) was performed for the second morphology, proportions, and targeted teeth harmony analysis, serving as model for subsequent silicon guide impression and for mock-up. An impression of opposing dentition was also made with irreversible hydrocolloid. An occluding centric relation record and a face bow transfer were obtained with poly (vinyl siloxane) material. A1 shade was chosen for this patient. The mock-up and prosthetic prototype, could then be observed (Figure 4A).

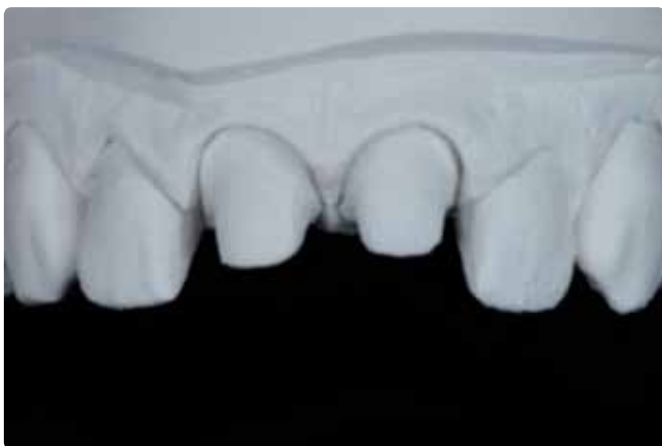
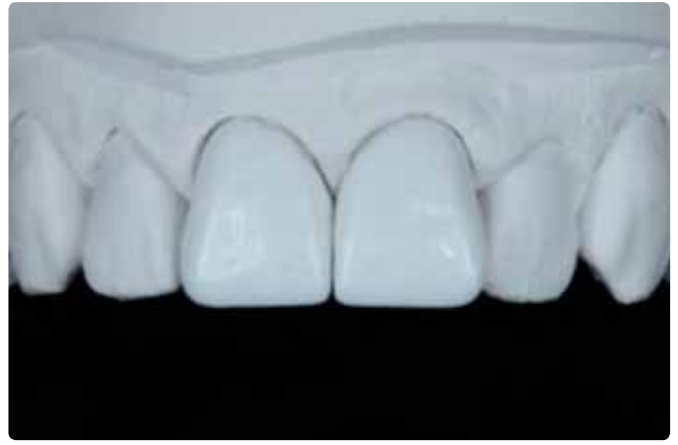
Figure 3a-b: Facial view of definitive stone cast to be scanned: (A) showing preparations and (B) with functional waxing of crowns.

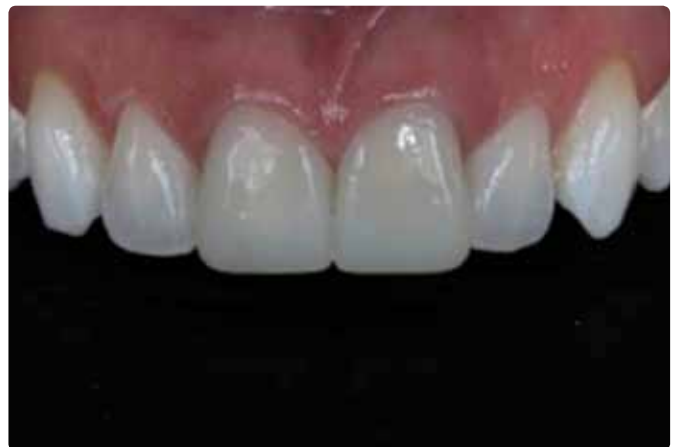
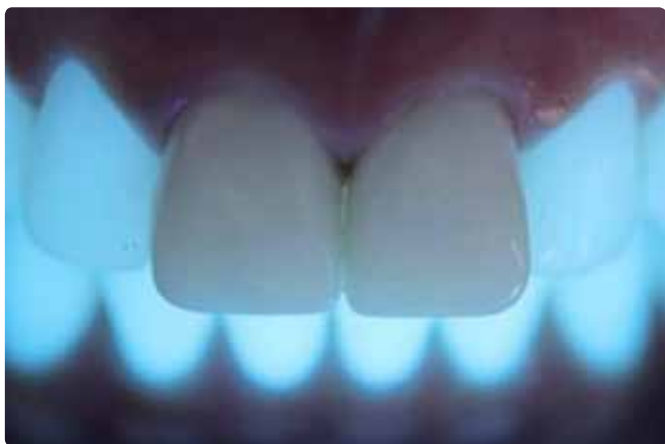
Figure 4a-b: (A) Anterior close-up showing morphological reproducibility of restorative mock-up technique made by bis-acrylic resin Structur 2 SC (VOCO GmbH), resulting into definitive prosthetic prototype; (B) anterior close-up of FIRST treatment proposal showing fluorescence of noncrystallized Suprinity infrastructures in accordance to virtual design of anterior crowns using CEREC system and Biocopy software.

A novel zirconia-reinforced lithium silicate (Suprinity, Vita) was used in this clinical case report. A digital impression was made, chairside with the intraoral scanner of CEREC system and used as basis for the virtual design (Figure 4B). Using Bio-coppy software, new crowns were amended to restore the incisors' shape and conform to the existing teeth's shape, based on a "double scanning" technique. Biting edges and facial profiles were improved and the virtual cast positioning on the occlusal plane to obtain the median line (considering curves of Spee and Wilson). Insertion axis was then determined followed by die making process and the cervical tooth preparation margin delimitation and also the desired area for the virtual wax up for a crown suggestion. At the end of this process, it was possible to superpose the wax up image onto the definitive suggestion and to visualize the definitive crown in the selected zirconia block. With zirconia ceramic material ready for machining, crown copings were obtained and ceramic veneer was applied. Two different projects were made for the clinical treatment (Figures 5A and B), with different material fluorescence degree at the second treatment proposal (Figure 5B),

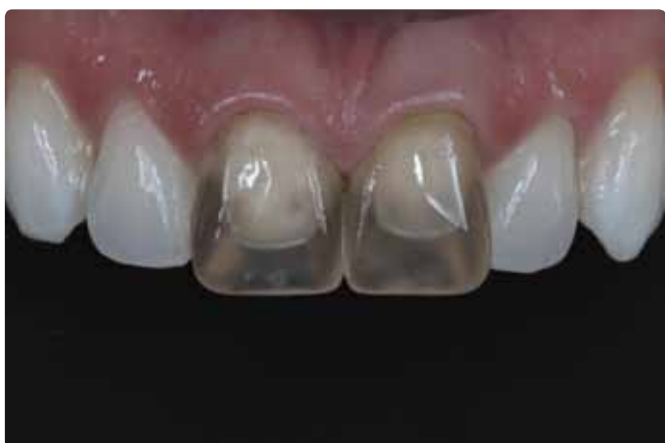
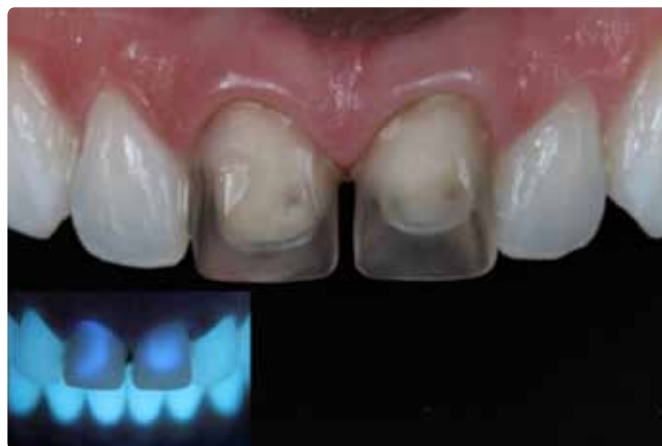
Figure 5a-b: (A) Anterior close-up of FIRST treatment proposal showing anterior view of milled Suprinity lithium silicate crowns in unfinished state. Note amber appearance in this phase (before being "sintered"); (B) Anterior close-up of SECOND treatment proposal showing milled Suprinity lithium silicate crowns in unfinished state. Note morphology, harmony and more esthetic perspective checked at "unsintered" phase and fluorescence of noncrystallized Suprinity infrastructures.

thus matching the first treatment proposal chosen by both patient and clinician. The use of crowns, manufactured with the new glass ceramic material was attempted. Milled lithium silicate crowns in the unfinished state may be observed in Figures 5A and B. The layer was made with VM.¹¹ Ceramic restorations were then glazed and fired. It is important to highlight that the left lateral incisor was in a palatal position relative to the spatial alignment of adjacent teeth generating a blackout shade and perception due to the incidence of low light on this tooth. For this purpose, a partial laminate was carried out to modify the buccal morphology, allowing a greater volume. There was no need for this tooth preparation, allowed a favorable insertion path for the laminated restoration. A VM¹¹ ceramic was used following the technique of 'refractory die'.

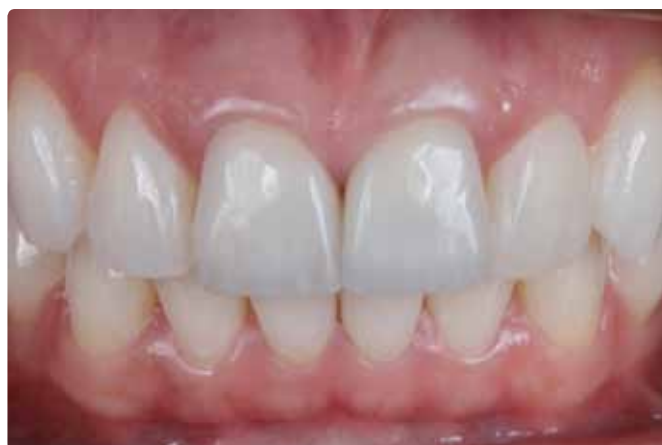
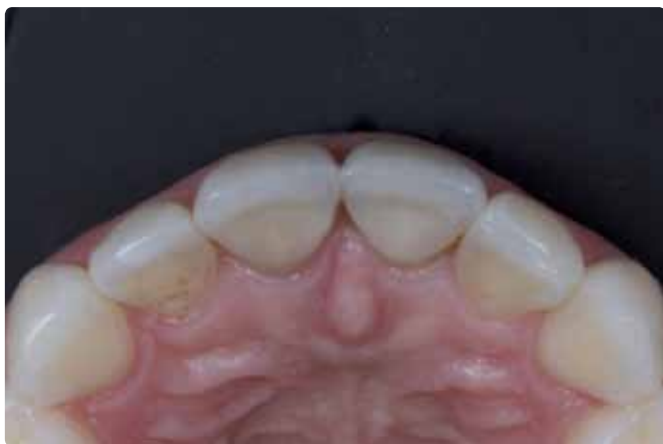
Figure 6a-b: Anterior (A) and (B) incisal close-ups of treatment proposal chosen by both patient and clinician: definitive crowns (right maxillary central incisor and left maxillary central incisor) and a ceramic veneer (left maxillary lateral incisor) after cementation.

Interproximal contacts were checked before cementation. Tooth surface was treated with 35% phosphoric acid before prophylaxis, followed by water cleansing. Ceramics were etched with 10% HF for 20 s and cemented with a resin-based luting cement, as recommended by the manufacturers. Figure 6A shows intercusp evaluation for teeth's position and harmony panoramic view. An incisal view can be seen in Figure 6B. The same arch harmony can also be seen in Figure 7 after cementation with definitive result in Figure.⁸ The patient received all postoperative care instructions and followed-up for 2 years (Figure 9). In the first two months, the patient returned to the clinic every 30 days and currently every 6 months.

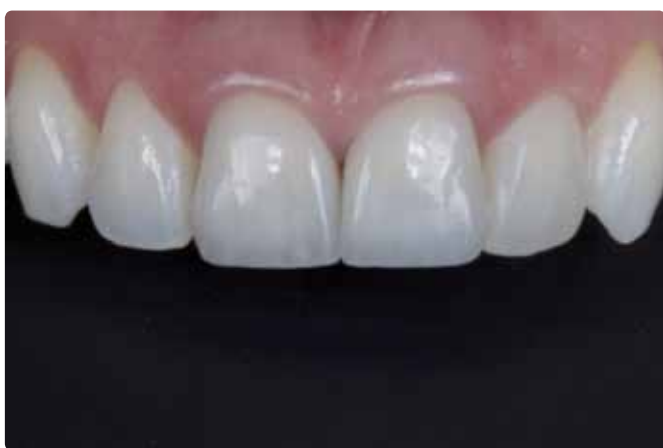
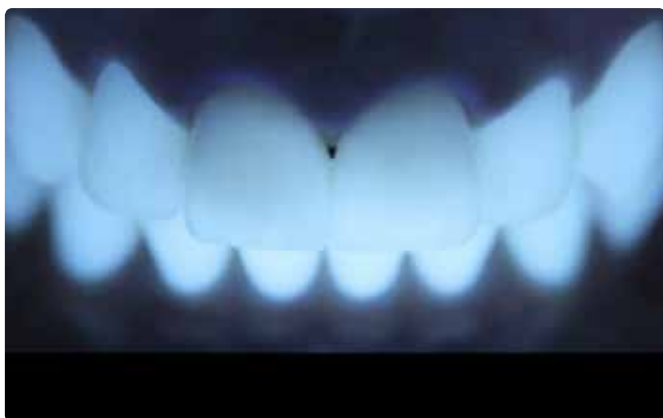
Figure 7a-b: Post-cementation verifications: (A) Soft tissue healthy and (B) Fluorescence.
